Title: Moisture-Induced TBC Spallation on Turbine Blade Samples

James L. Smialek

NASA Glenn Research Center

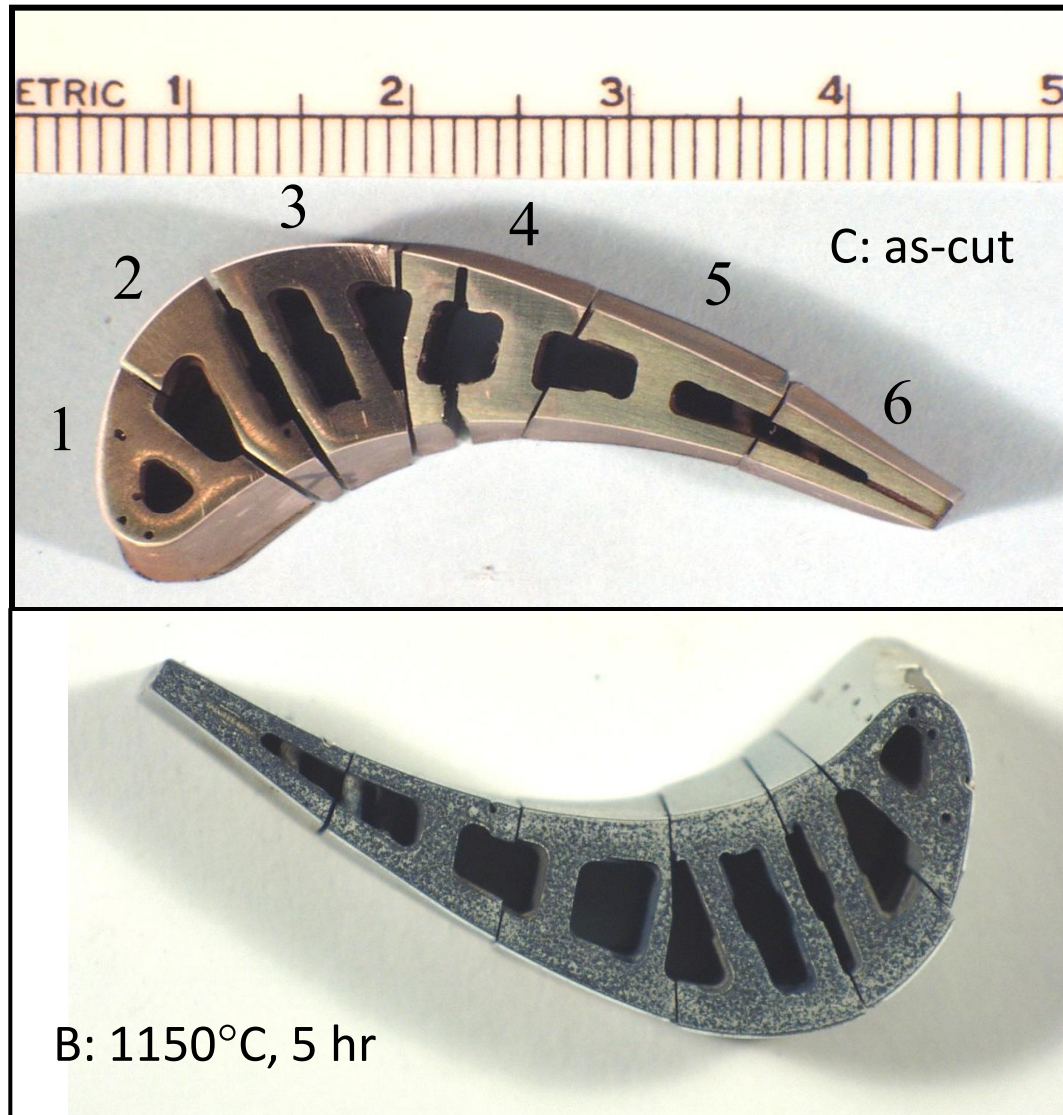
Figure 2

Figure 2. Sliced TBC coated turbine blade chord and six test sections for water drop experiments. Section C as-cut and sanded and Section B after oxidation at 1150°C for 5 hr.

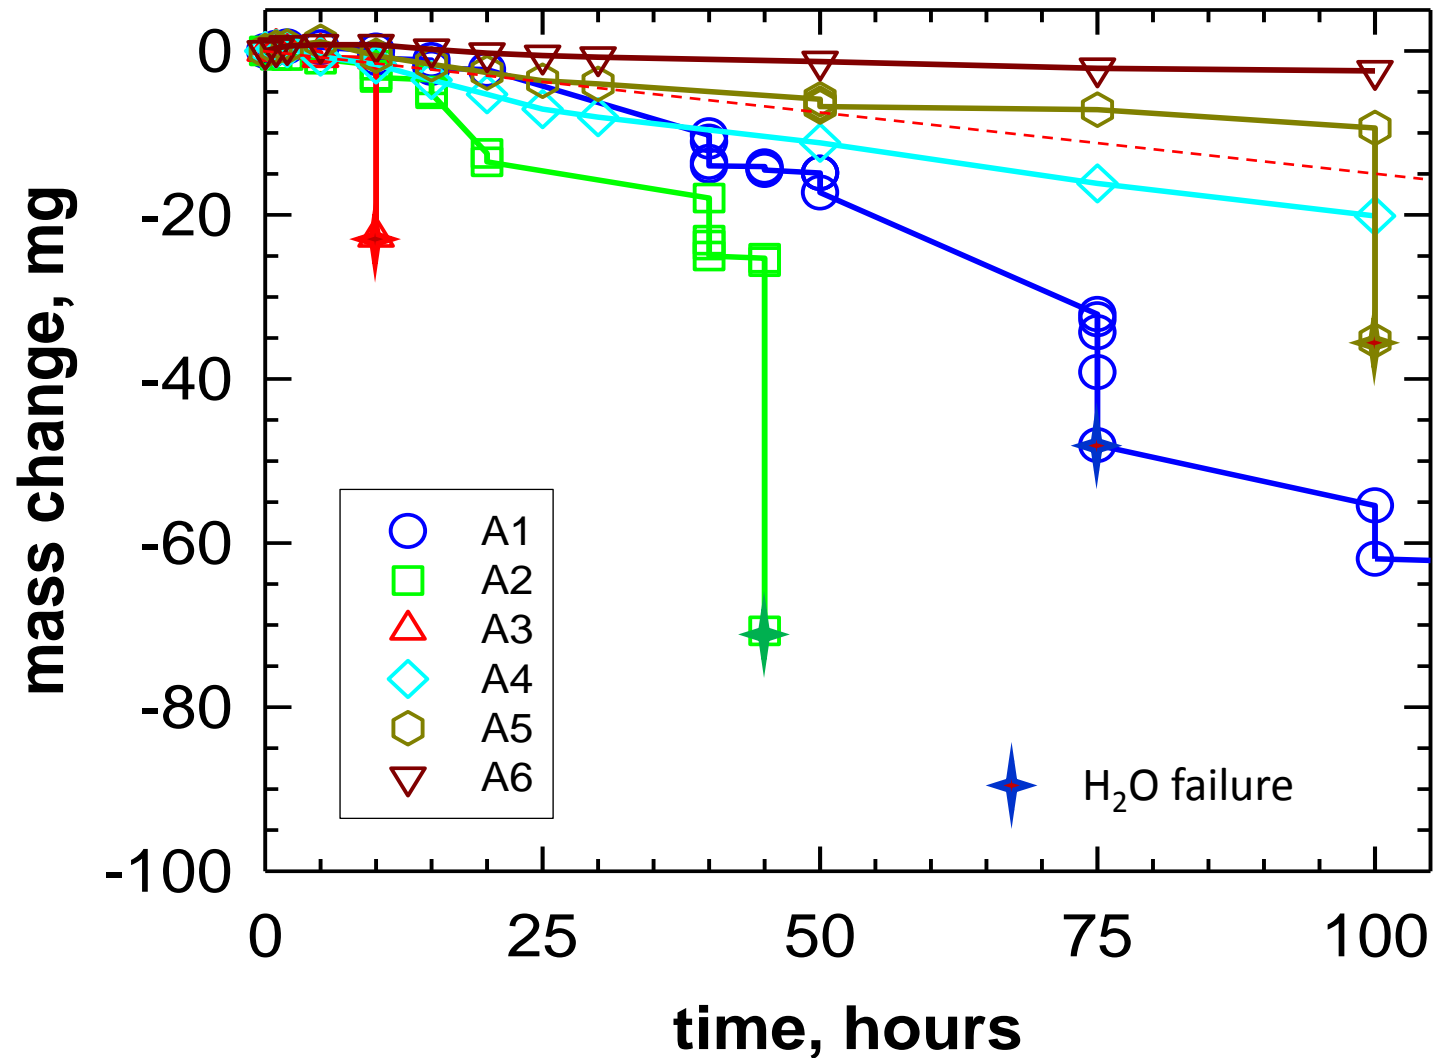
Figure 3

The weight change with 1100°C oxidation time is shown for chord A samples in [figure 3](#). Here the test begins with most samples producing a small weight gain on the order of 1 mg in the first 10 hr. Eventually, weight loss occurred at an average rate (dashed line) of about 0.15 mg/hr after 10 hr, just due to oxidative issues with the cut surfaces of the blade alloy. Additional drops in weight, often quite abrupt, occurred with partial TBC coating loss on one major surface of a sample. Failure occurred by both normal cool down stresses or by the water drop test, randomly, depending on the sample. (The water drop failures are indicated by the star-point symbols). Sample A1 exhibited a small amount of bare metal spallation at the leading edge after cool down from 40 hr of oxidation. Sequential immersions in acetone, alcohol, and water were performed at the 10, 15, and 40 hr test times, producing little additional weight loss. Sample A2 exhibited partial delamination early in the test, but the TBC remained loosely attached. It was subjected to the same sequential immersions as A1, again with little effect. Some loose TBC segments chipped off at 20 and 40 hr just due to handling. Sample A3 lost one surface of the TBC due to water immersion after just 10 hr of oxidation. Samples A4, A5, and A6 were relatively unaffected for the first 50 hr. Thus moisture induced failures can be seen for sample A3, A2, A1, and A5 occurring at 10, 45, 75, and 100 hr. total oxidation time, respectively. Failure by natural cooling also occurred for the other side of sample A1 at 75 hr.

Figure 3. Mass losses for 1100°C intermittent oxidation of Section A samples. Water drop spallation failures indicated by star symbol. Dashed line indicates approximate loss rate for uncoated superalloy cut edges.

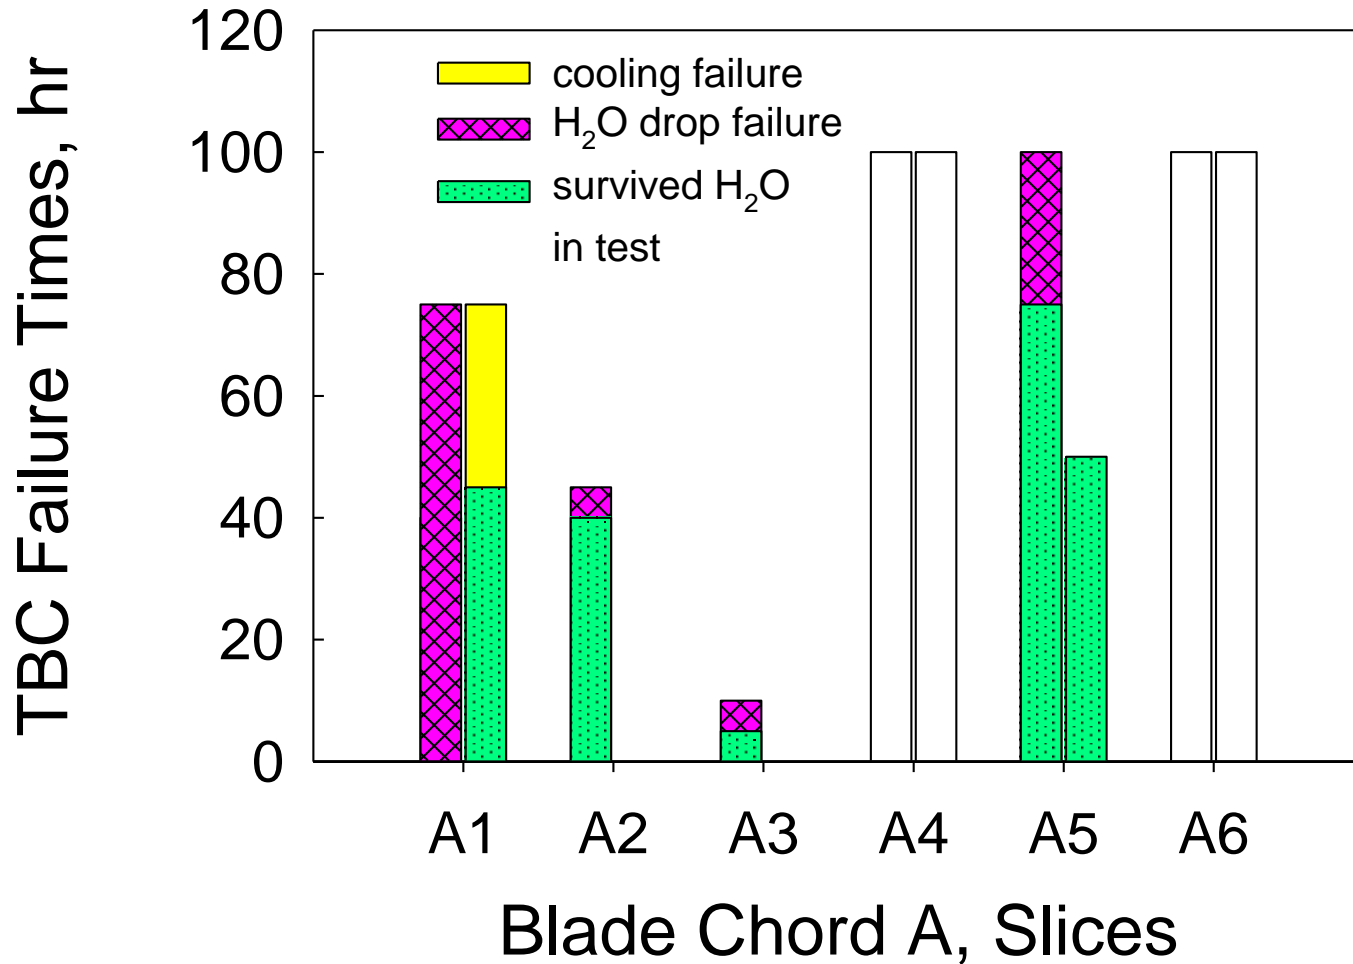
Figure 4

It is also important to acknowledge when failure does not occur by water drop testing and how these times relate to cooling failures, if any. It goes without saying that any moisture induced failure implies that the coating survived cooldown. Accordingly, a summary of the failure history of each sample is presented in [Figure 4](#). Here it can be seen that sample A1 first

exhibited cooling spallation at 75 hr, with more gradual losses from subsequent water exposures. Sample A2 survived moisture testing at 40 hr., then failed on immersion at 45 hr. and was pulled from further testing. Sample A3 survived immersion at 5 hr, then failed at just 10 hr, and this sample was also pulled. Sample A5 survived the water drop test at 50 and 75 hr, then failed with a water drop on one side at 100 hr. Finally, samples A4 and A6 both survived cooldown up to 100 hr oxidation (no water test yet), and are still in test.

Figure 4. Survival/failure history for TBC spallation from cool down and water drop tests. Section A, 1100°C intermittent oxidation. 100 hr maximum failure time for water drop (so far).

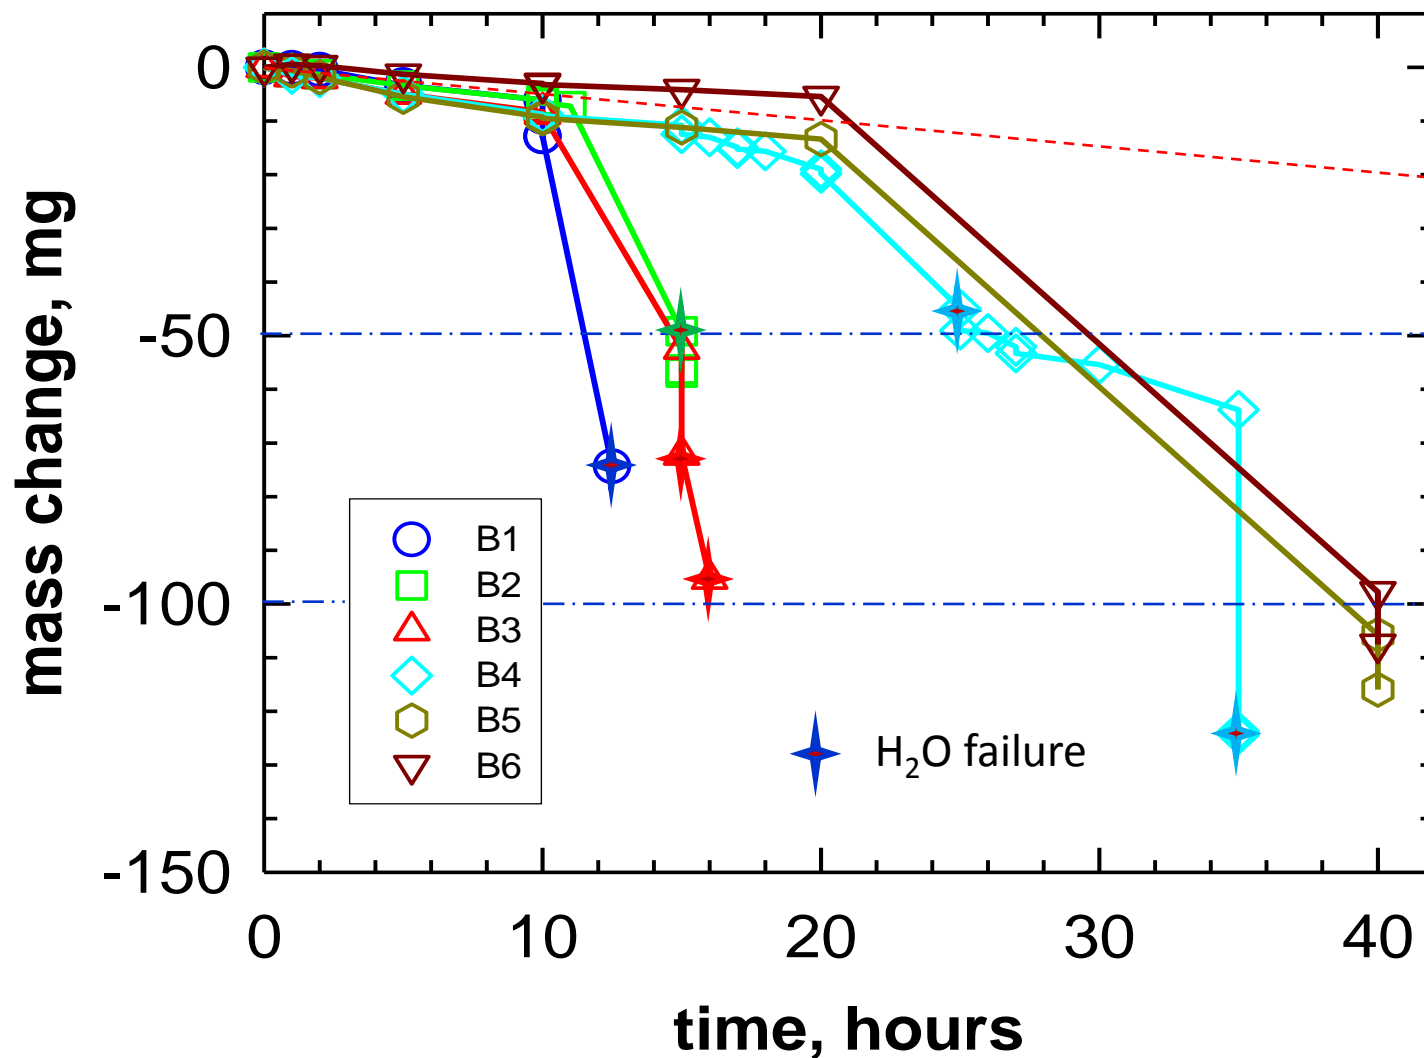
Figure 5

The weight change response for testing chord B at 1150°C is shown in [figure 5](#). Here about 10 mg weight loss was occurring after 20 hr just due to blade alloy oxidation, or at an average rate of 0.5 mg/hr. An additional 50 mg or so drop in weight, often quite abrupt, was generally associated with coating failure on one major surface of a sample. Moisture induced failures can be seen for samples 1-4, occurring over 12.5 to 35 hr total test time. A summary of the survival/failure history of each sample is presented in [figure 6](#). Here it can be seen that sample B1 first exhibited cooling spallation and subsequent water failure occurring at 12.5 hr. Sample B2 survived moisture testing at 10 hr, then failed at 15 hr. Sample B3 showed partial failure on cooldown and more with moisture exposure after 15 hr, then completed spallation by moisture failure at 16 hr. Sample B4 survived the water drop test at 20 hr, then partially failed at 22.5 hr. The remnant coating survived moisture exposure at 30 hr, then failed at 35 hr. Finally, samples B5 and B6 both survived cooldown and the water drop test at 20 hr, then failed on cooldown at 40 hr (due to the final long 20 hr interval with no inspection interval inbetween).

Figure 5. Mass losses for 1150°C intermittent oxidation of Section B samples. Water drop spallation failures indicated by star symbol. Dashed line indicates approximate loss rate for uncoated superalloy cut edges. Horizontal dot/dash lines indicate approximate magnitude of mass loss due to TBC spallation from 1 or both major surfaces.

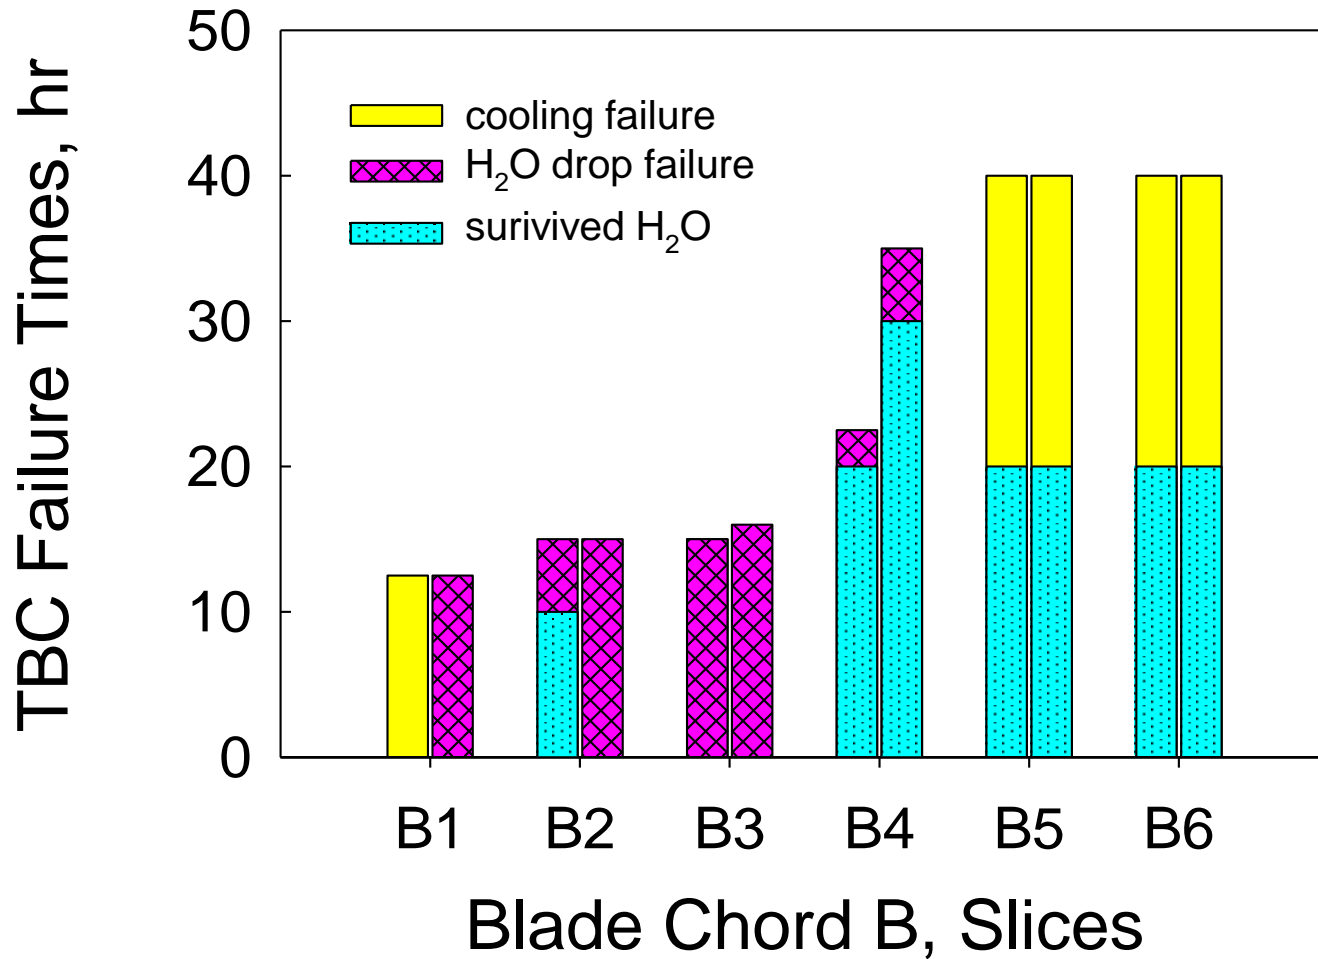
Figure 6

Figure 6. Survival/failure history for TBC spallation from cool down and water drop tests. Section B, 1150°C intermittent oxidation. 35 hr maximum failure time for water drop.

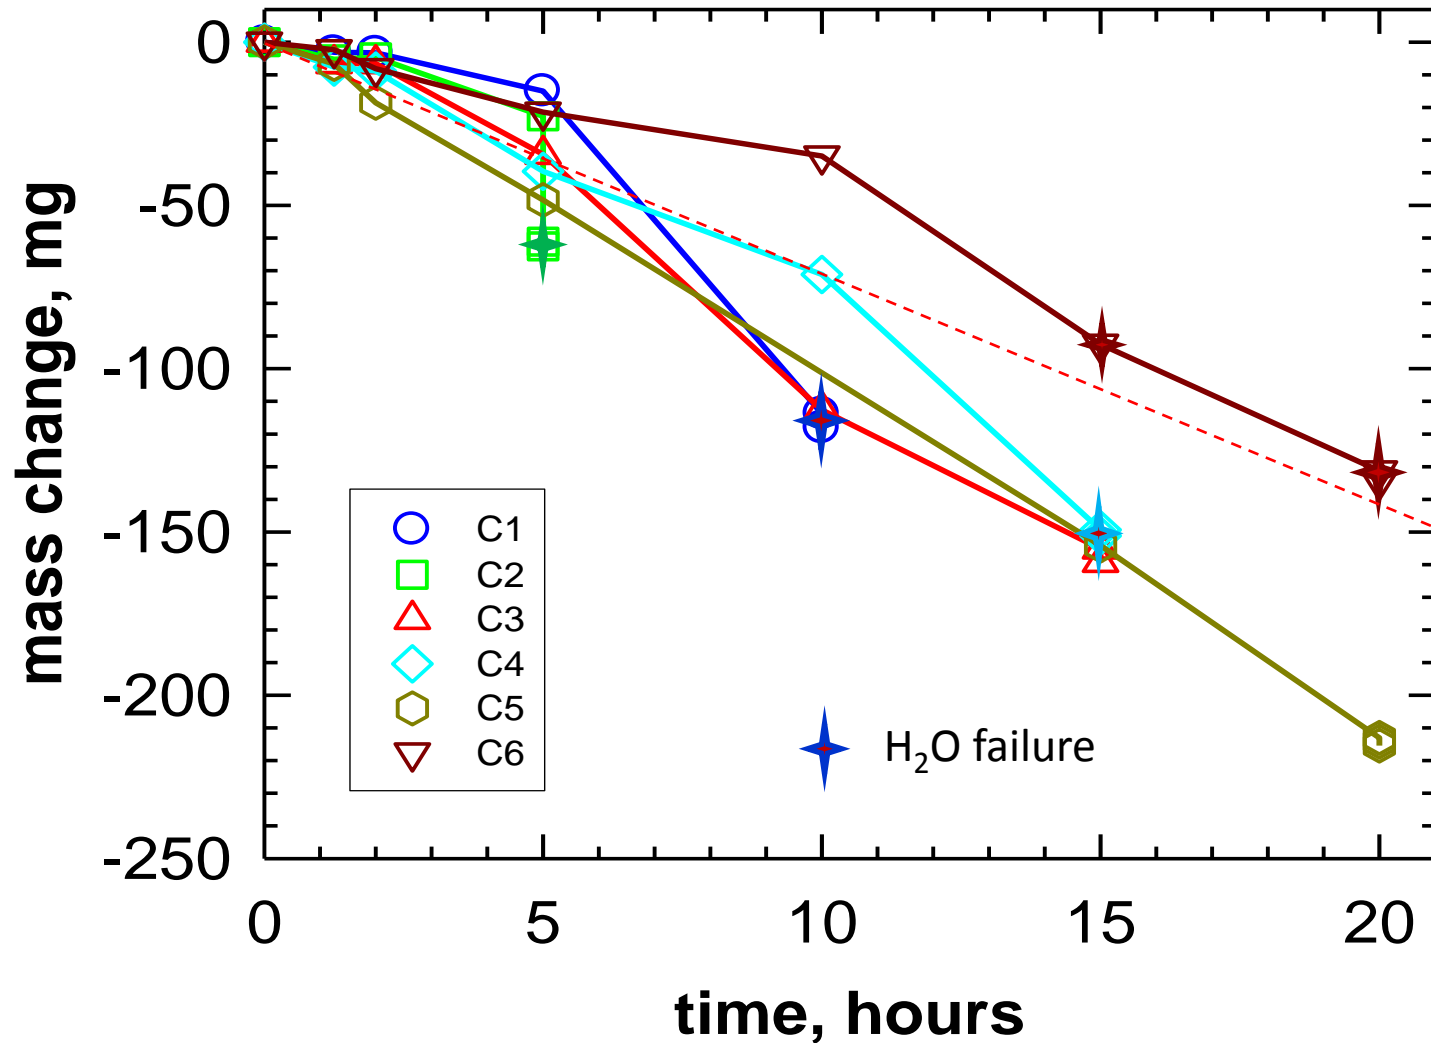
Figure 7

The weight change response for testing chord C at 1200°C is shown in [figure 7](#). Now the oxidation of the base metal produced nearly 50 mg weight loss after just 5-10 hr oxidation, or at an average rate of ~7 mg/hr. These large losses obscured any additional abrupt drops in weight associated with visual observation of coating failure. Moisture induced TBC failures are noted for samples C1, C2, C4, and C6 occurring at 5, 10, 15, and 20 hr total test time. A summary of the survival/failure history is presented in [figure 8](#). Here it can be seen that sample C1 spalled exclusively by water failure at just 5 hr. Sample C2 spalled partially by cooldown, then by moisture testing, both at 10 hr. Samples C3-C6 exhibited partial failure on cooldown from 10-20

hr, survived moisture testing for 5-15 hr, and failed in water drop tests at 15 and 20 hr. At this temperature the overlap of the various survival/failure times were more prevalent, as the lifetimes become highly compressed due to greater degradation and oxidative stresses.

Figure 7. Mass losses for 1200°C intermittent oxidation of Section C samples. Water drop spallation failures indicated by star symbol. Dashed line indicates approximate loss rate for uncoated superalloy cut edges.

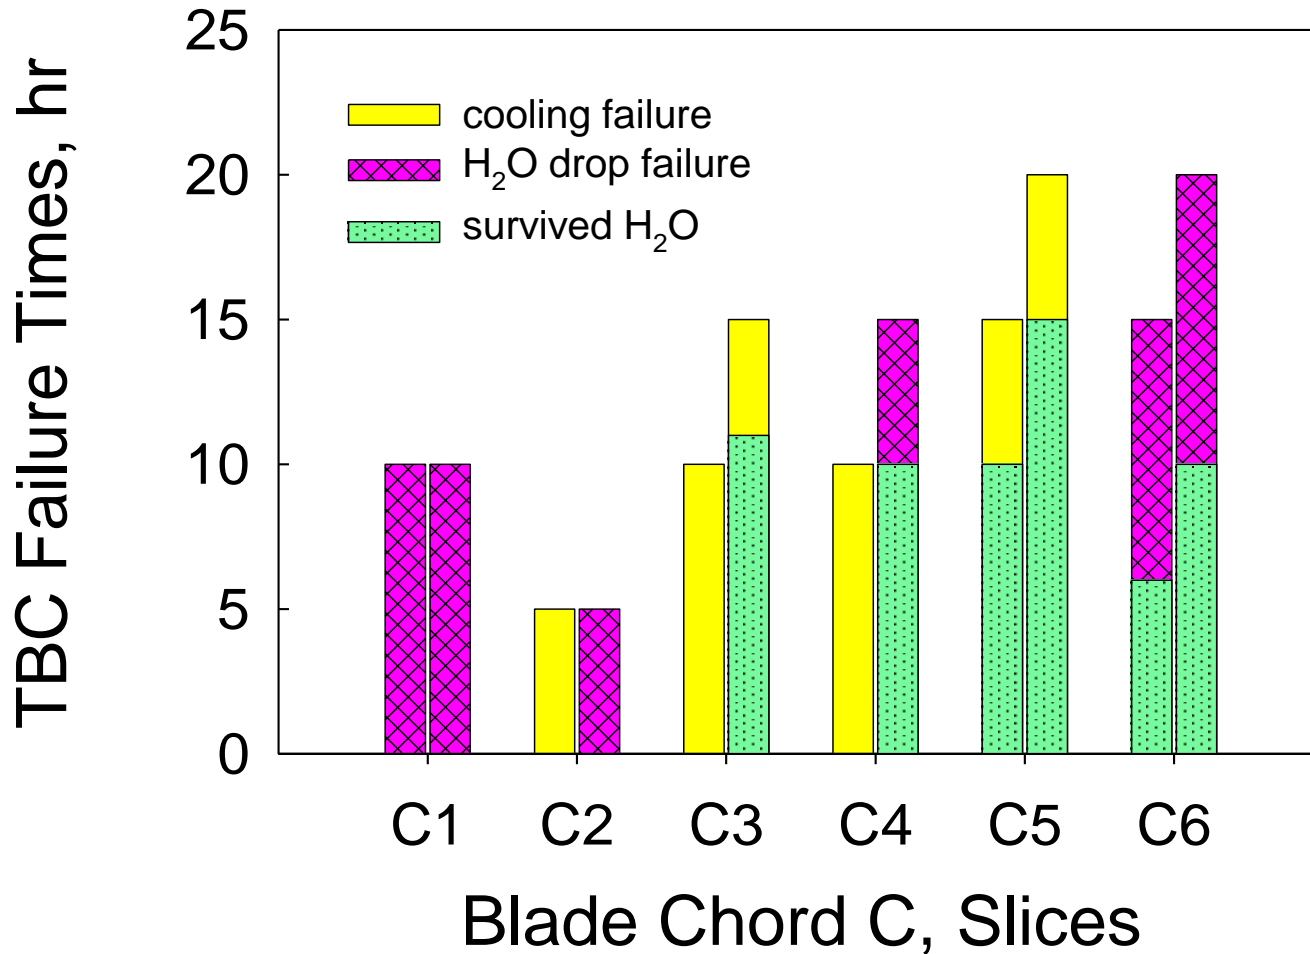
Figure 8

Figure 8. Survival/failure history for TBC spallation from cool down and water drop tests. Section C, 1200°C intermittent oxidation. 20 hr maximum failure time for water drop.

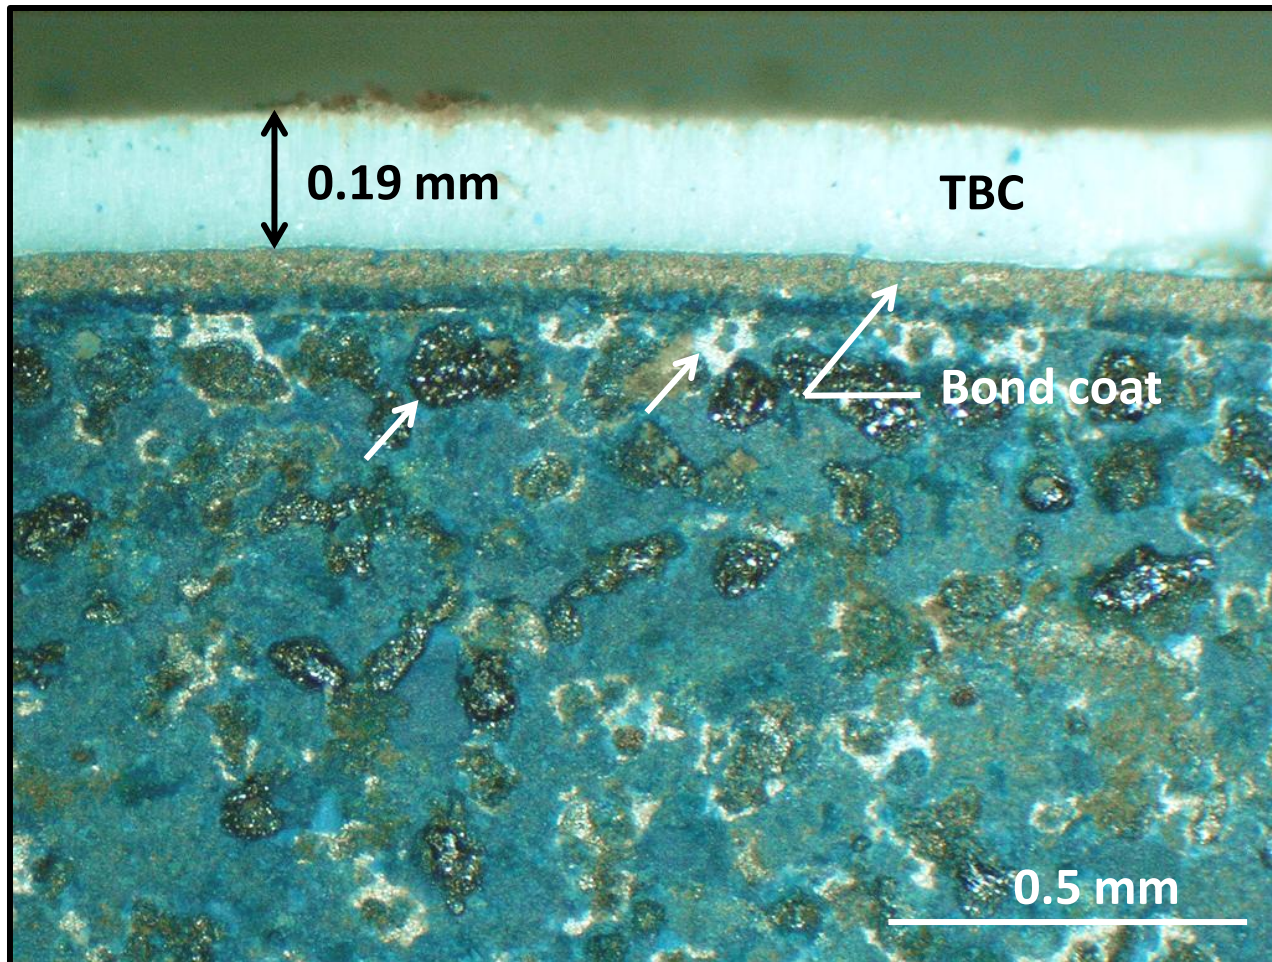
Figure 9

The appearance of a cut surface of sample B2, oxidized at 1150°C for 5 hr is shown in the macrograph of **Figure 9**. The TBC is seen to be intact as the white top layer. It is attached to the Ni(Pt)Al bond coat which exhibits only modest oxidation. The exposed substrate however shows a preponderance of blue (NiAl₂O₄ spinel) scale. Spalling to bare metal (reflective) and large grain NiO nodules (dark) can be seen in local areas (arrows). These substrate features undoubtedly account for the majority of the weight changes discussed above that were not associated with TBC spallation.

Figure 9. Optical micrograph of cut edge of sample B2 after 5 hr oxidation at 1150°C. Intact TBC, lightly oxidized bond coat, dark NiO nodules and bright bare metal spalling on superalloy cut edge.

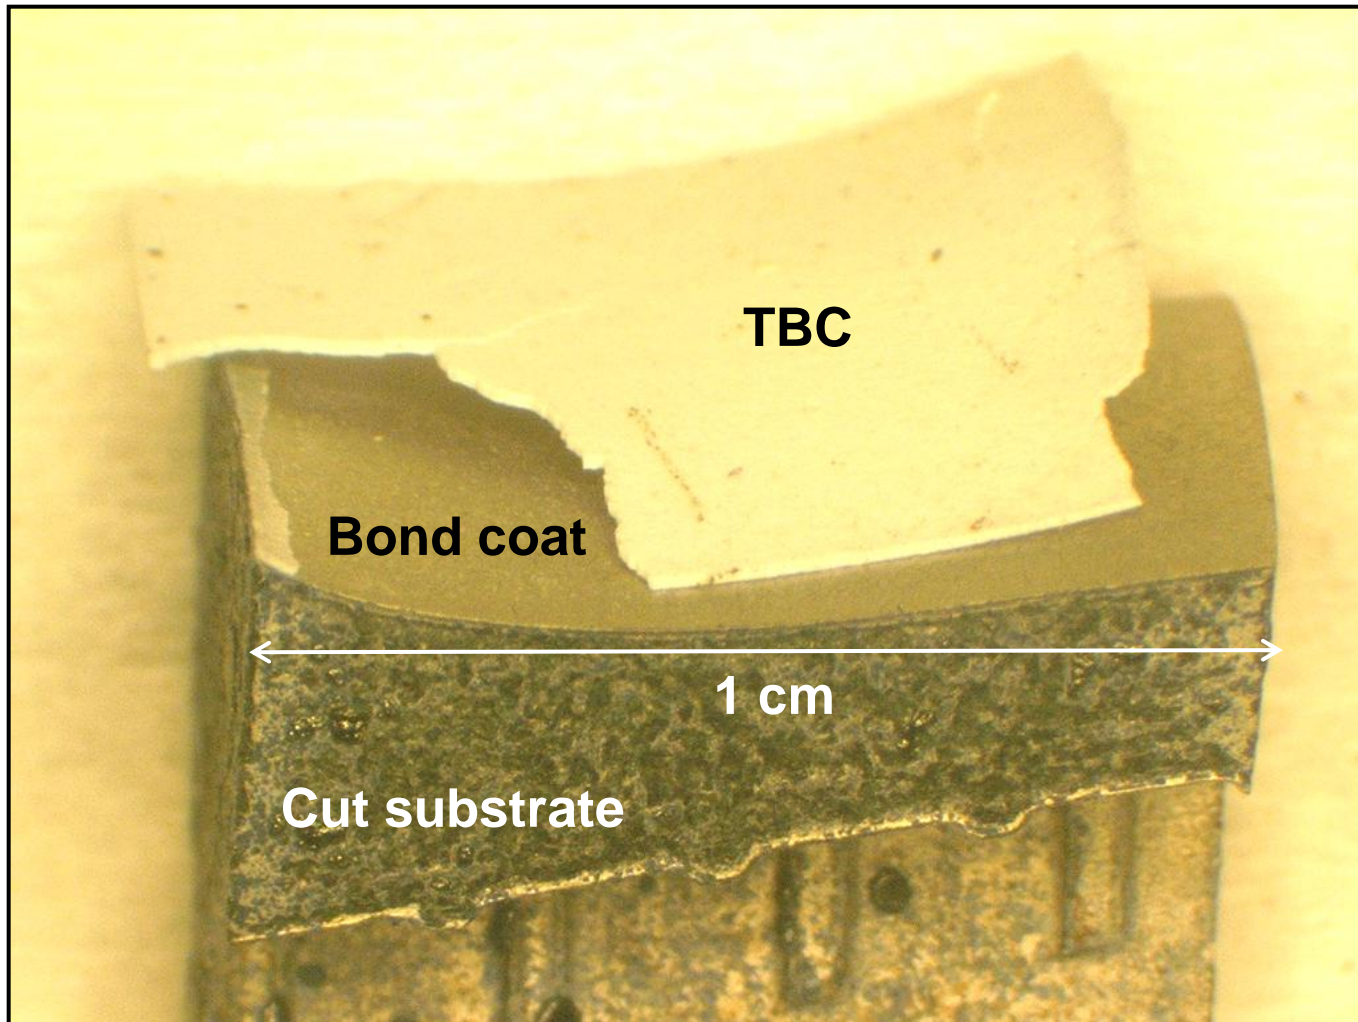
The water test sometimes results in complete delamination and removal of the TBC in large intact pieces. Such a result is shown in **Figure 10** for sample C2 that failed by immersion in water for 2 min. after 5 hr oxidation at 1200°C. The single TBC flake is positioned against the surface it delaminated from, but flipped inside out for an improved view. The metal side revealed after delamination is seen to be relatively clean and oxide-free.

Figure 10. Optical macrograph of Sample C2 after complete TBC delamination from water drop test following 5 hr intermittent oxidation at 1200°C.

Sample C2: 1200°C, 5 hr.
100% Delamination after 2 min water immersion

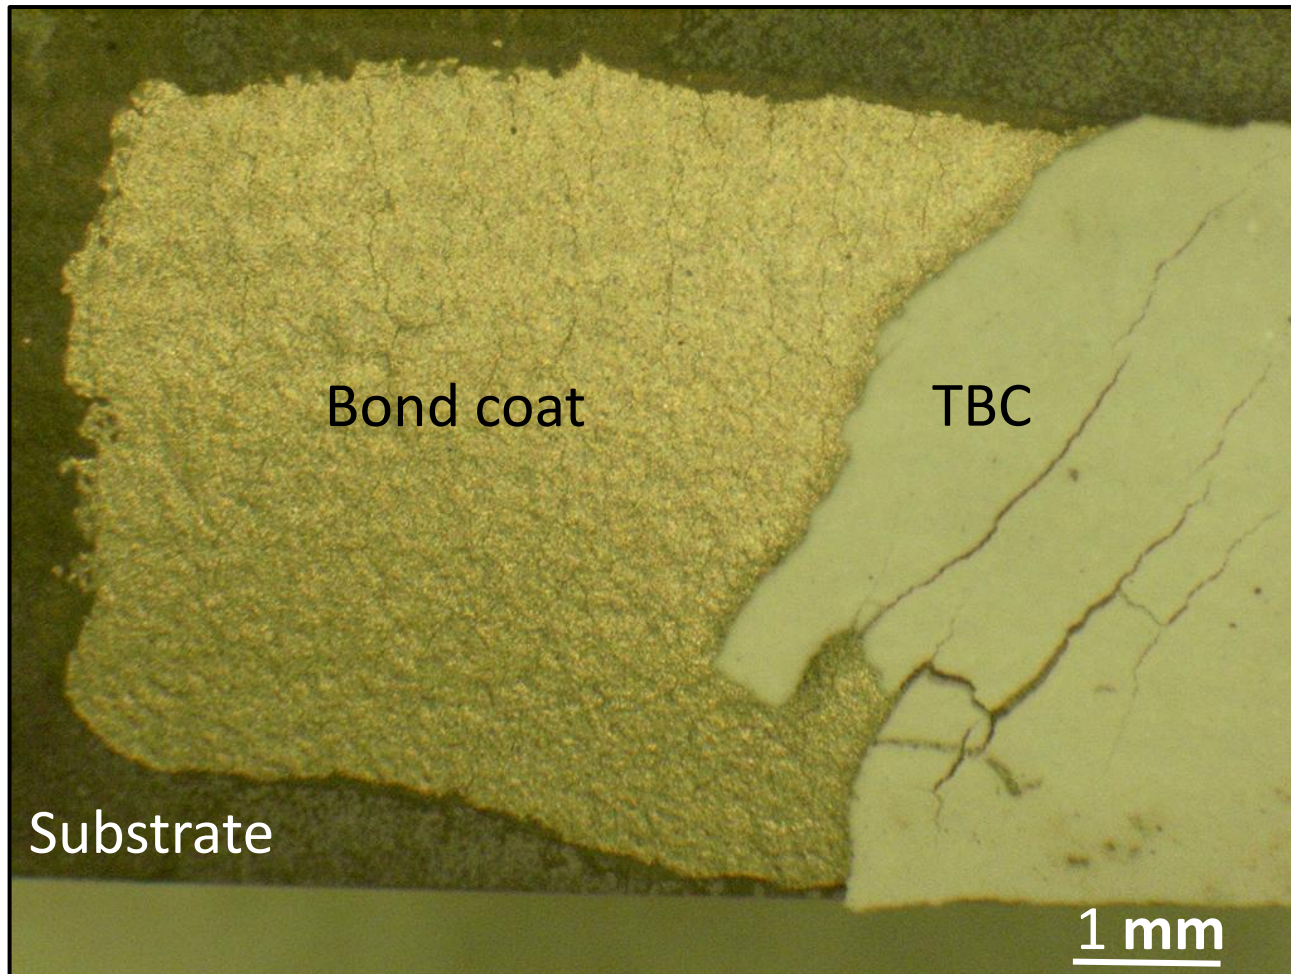
Figure 11

F3.4-3. A3, 1100°C, 10 hr, 10x. Exposed metal of bond coat and retained TBC.

Another typical appearance of a tested and failed sample is shown in **Figure 11**. Here some TBC is shown damaged and detached or partially adherent. The exposed bond coat is also apparent as reflective clean metal. Bond coat damaged from chipping, then producing substrate oxidation, is seen around the cut edges.

Figure 11. Optical macrograph of Sample A2 after partial TBC delamination resulting from water drop test following 10 hr intermittent oxidation at 1100°C. Reflective bare metal bond coat revealed under delaminated TBC and multiply cracked retained TBC area.

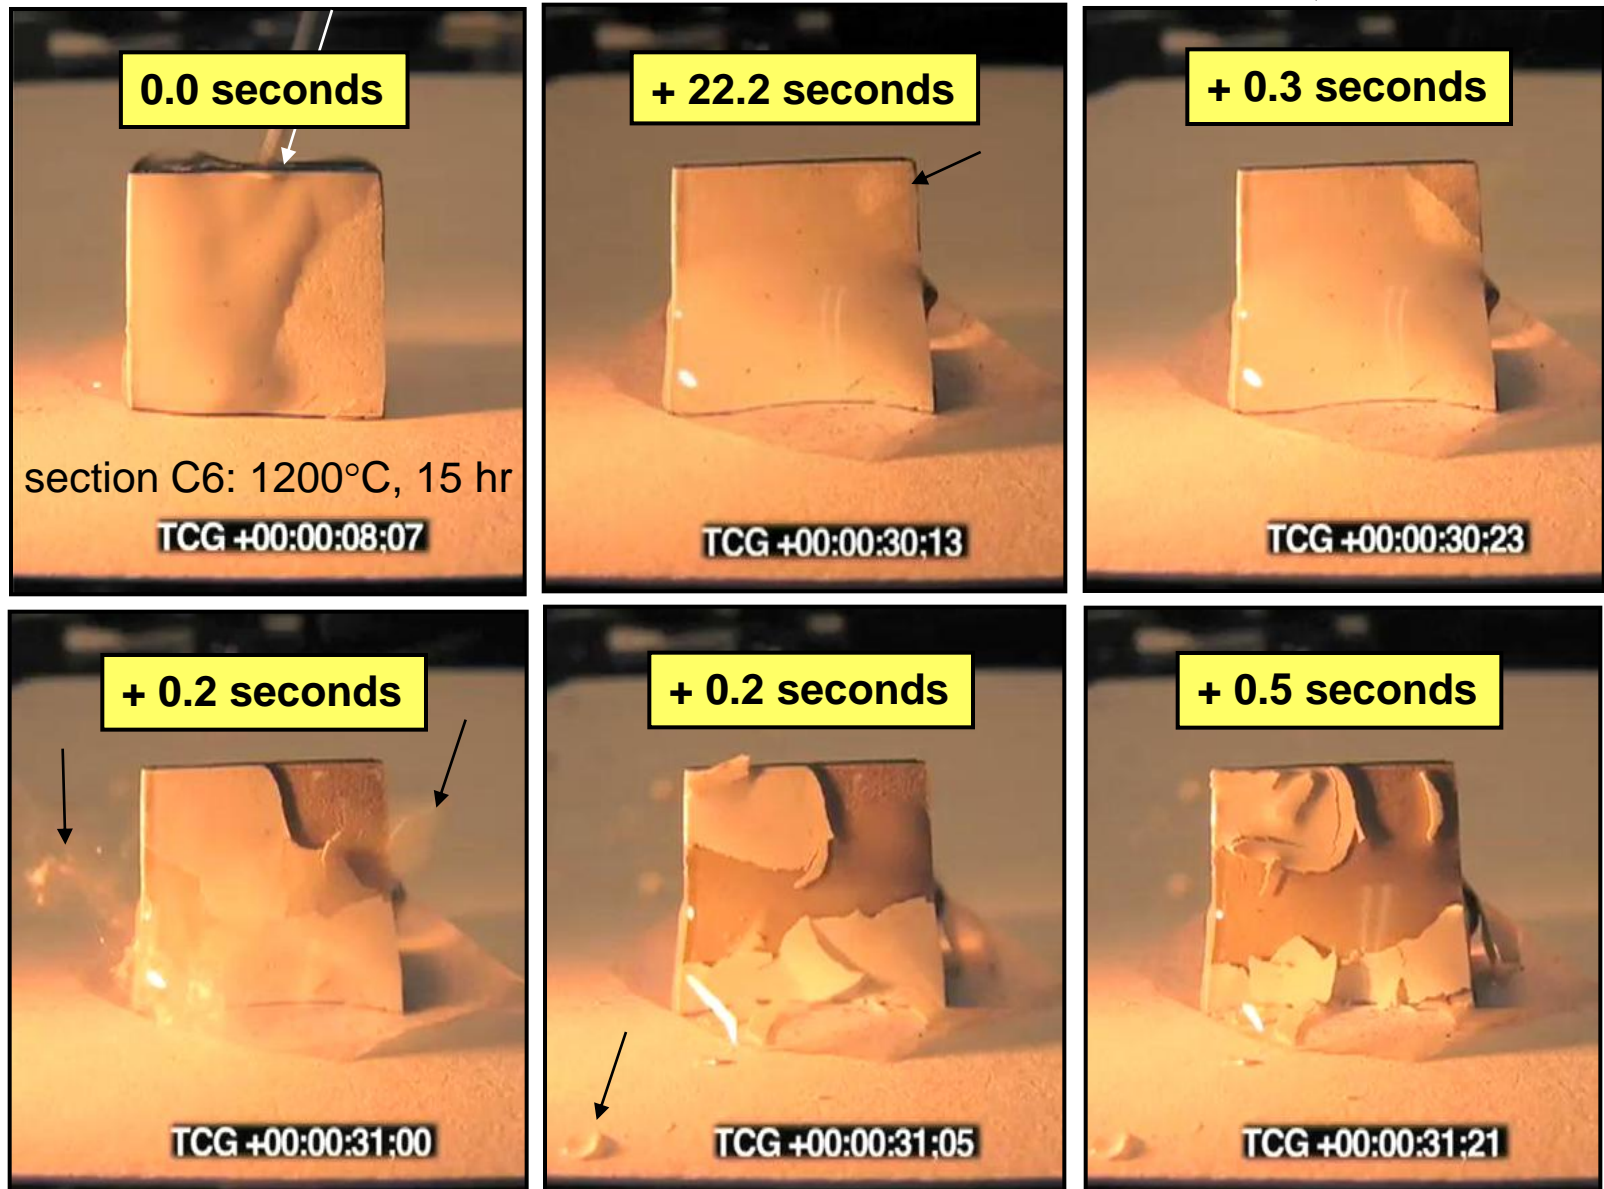
Often, the TBC was observed to delaminate in very small fragments in a more or less sequential fashion, progressing from a single failure point, generally near a cut edge. A video sequence of such a progression was obtained for a number of samples when they were exposed to a water drop stream from a wash bottle. Still frames captured from such a video are presented in **Figure 12** for sample C6 oxidized at 1200°C for 15 hr. The first frame shows the intact sample as the water stream is applied from the upper right. The superimposed time code bar is in hr:min:sec; 1/30 sec., indexed from the start of the video. The next frame shows that failure initiated at the

upper right edge (arrow) after about 22 seconds of water exposure. Then the rapid progression of delamination is seen in the subsequent frames, spanning about 1 sec. additional cumulative time expired. In the lower left frame both water and a TBC segment (arrows) are captured in flight due to the energetic detachment of the TBC. The water droplet can then be found in the bottom center frame at rest on the table top (arrow). After rinsing and drying (not shown), very little TBC remained bonded to the sample.

Figure 12. Selected frames of a video sequence recording the water drop test for sample C6 after 15 hr intermittent oxidation at 1200°C. 22 seconds for incubation and fractions of a second for successive delamination. Arrows show crack initiation, water droplet and coating in flight, and water drop at rest.

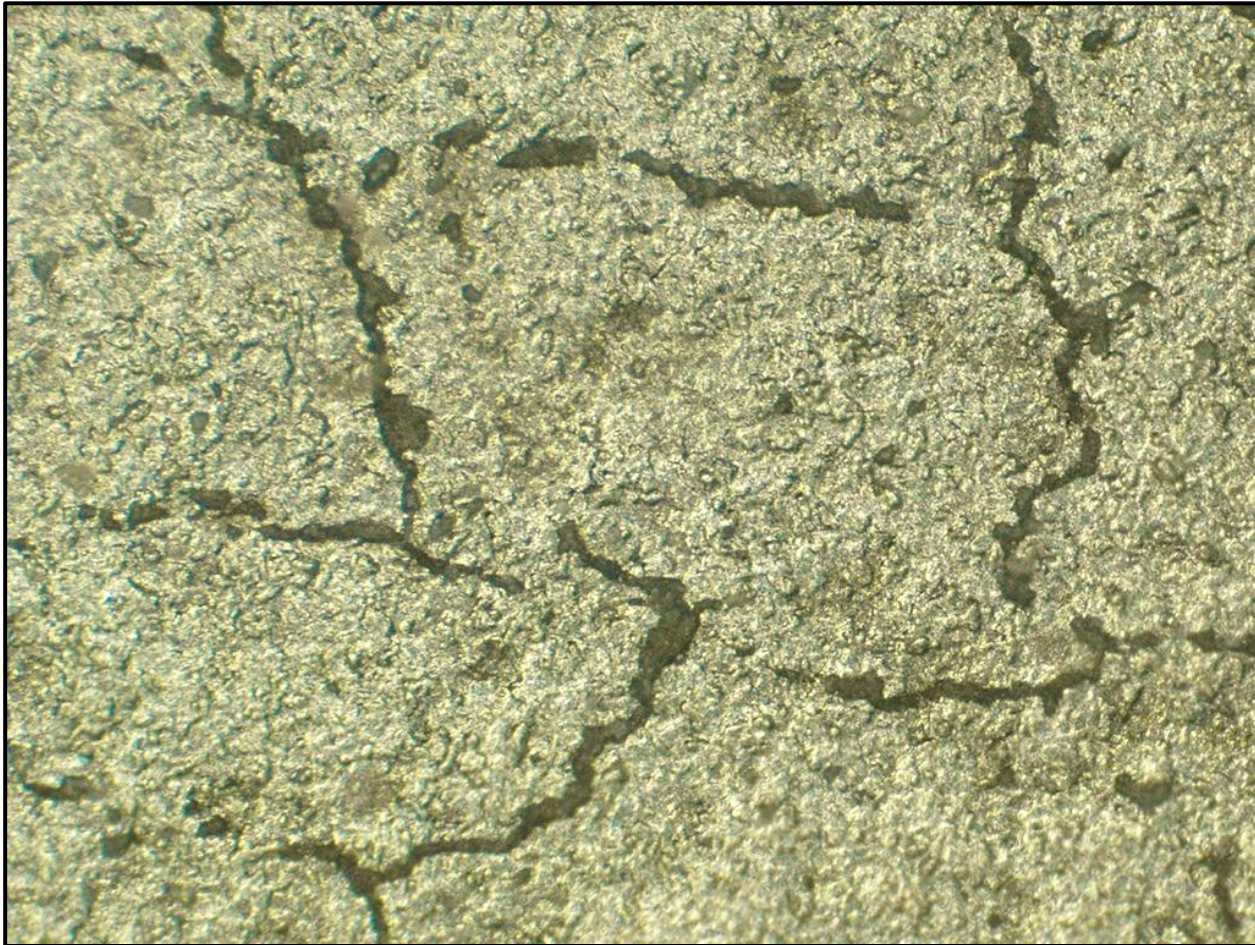
Figure 13

While the overall exposed bond coat appearance is that of clean reflective metal, closer examination reveals additional detail. **Figure 13** is an optical surface micrograph of sample C2, oxidized at 1200°C for 5 hr. before failing by water immersion. It shows a series of entrained scale in more or less a grid like network of stringers.

Figure 13. Optical macrograph of Sample C2 after TBC delamination resulting from a 2 minute water drop test following 5 hr intermittent oxidation at 1200°C. Reflective bare metal bond coat and network of retained oxide.

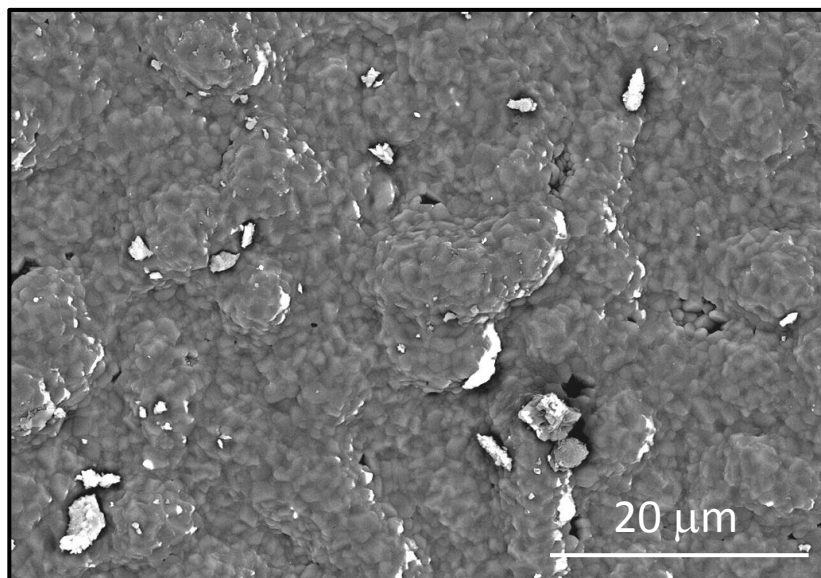
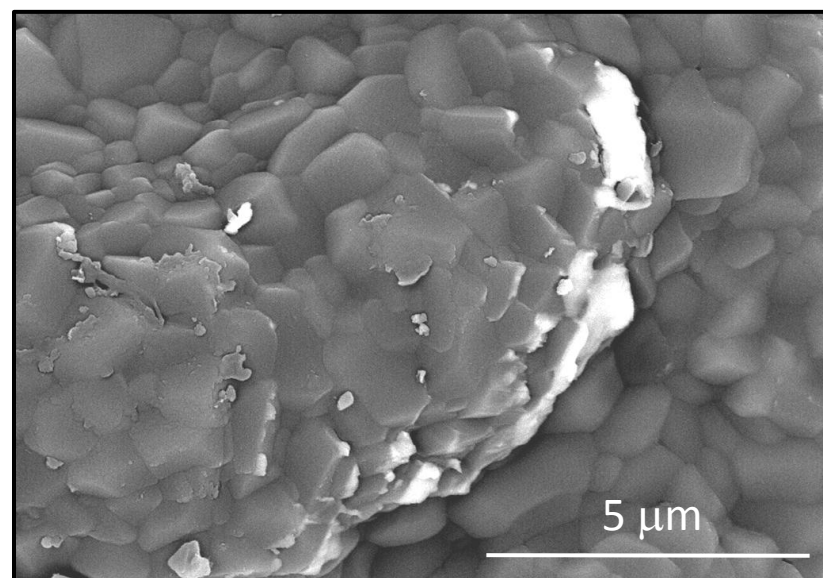
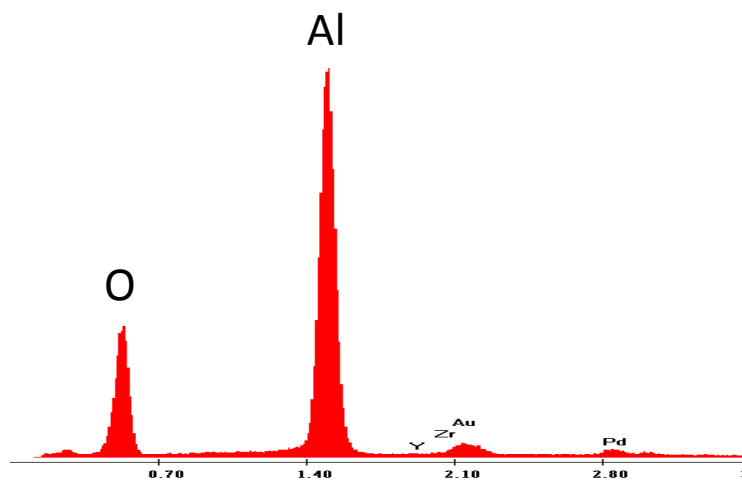
Figure 14

The surfaces exposed by TBC delamination were examined by SEM/EDS. **Figure 14** shows a typical area of the underside of a spalled fragment of coating. For the most part, the TBC fragment retained the thermally grown alumina scale which exhibited an undulating or rumpled morphology (**1a**). The scale underside grain morphology is apparent (**1b**) with most grains being in a 1-2 μm range. Some highlighted areas in backscatter imaging were shown by EDS to be Ni,Ta- rich oxide or Ni metal alloy. Attempts were made to examine the attached alumina scale in fracture sections of spalled TBC fragments, **Figure 15**. Unfortunately, no good section views of the scale were found, even though EDS identified the alumina scale away from the fracture section. It is seen that the TBC layer was about 140 μm thick here.

Figure 14. Backscatter SEM image and EDS spectra of exposed alumina grain surfaces attached to the underside of the spalled TBC. Sample B4, 35 hr intermittent oxidation at 1150°C.

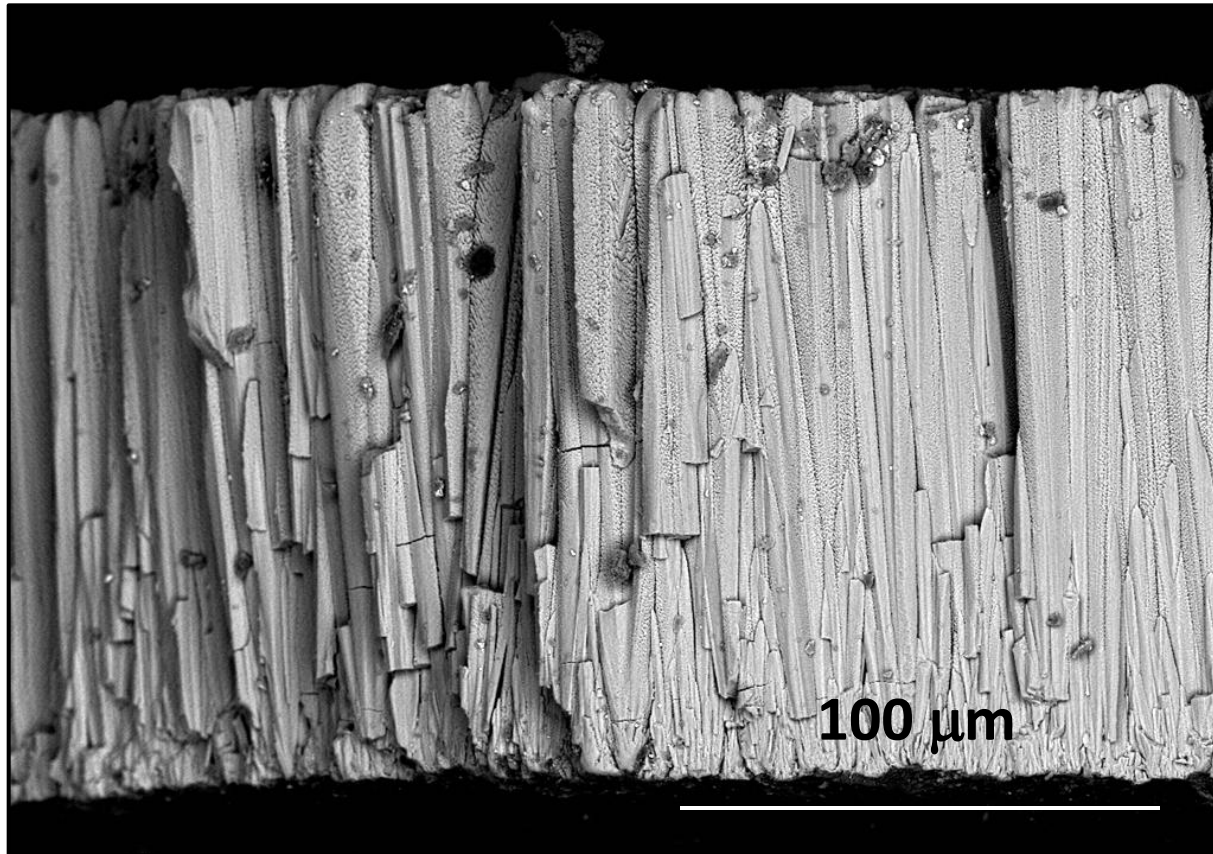
Figure 15

Figure 15. Backscatter SEM image of a fracture edge of the spalled TBC. Sample B4, 35 hr intermittent oxidation at 1150°C.
